## Cumberland County Courthouse Project Narrative

### **Purpose of BCR Contract**

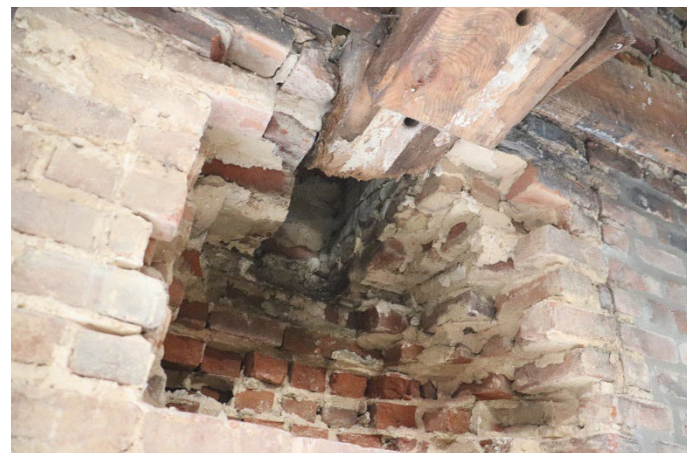
Engineers discovered that several heavy timber roof trusses were severely deteriorated, with settlement of more than twelve inches at multiple bearing points.

*Figure 2: Deterioration of the wood trusses*

The building was deemed unsafe and closed to the public. Emergency shoring was installed to prevent collapse of the roof and clocktower, but it was only a temporary measure. Cumberland County sought a permanent stabilization program to preserve the courthouse for future generations.

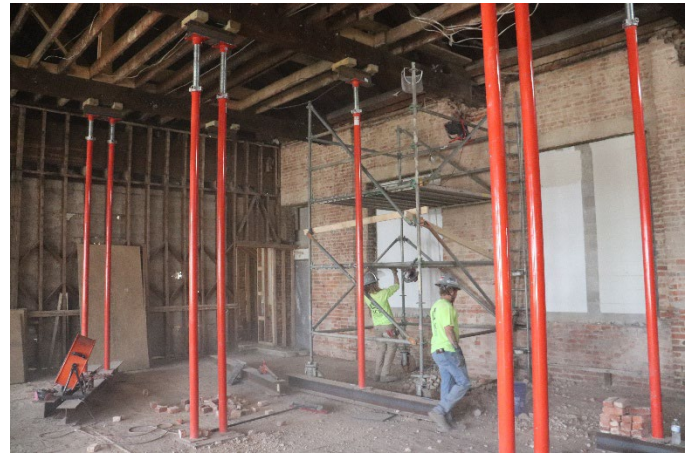
*Figure 3: Shoring holding the roof aloft while the team works*

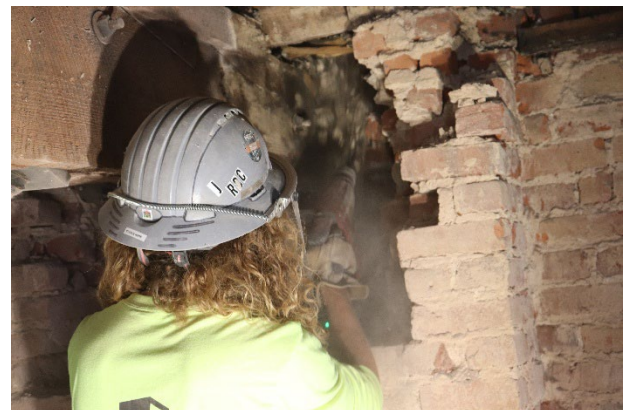
*Figure 4: Demolition of the deteriorated masonry*

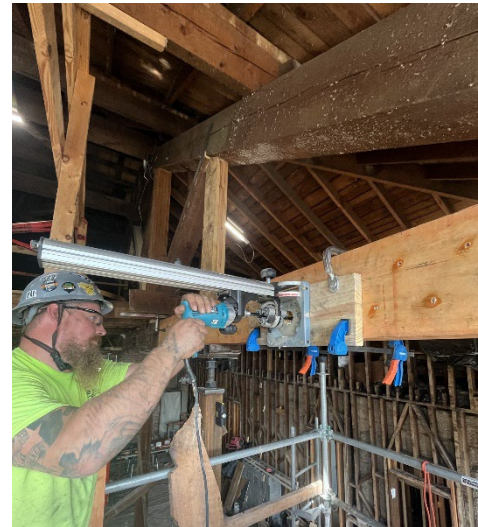
*Figure 5: Drilling holes in truss to install additional support system*

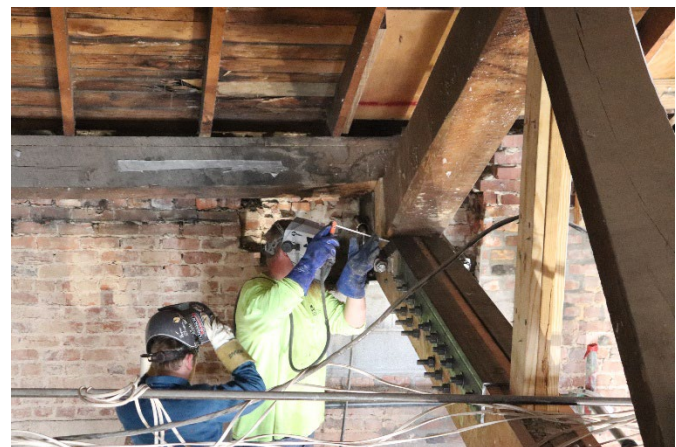
*Figure 6: Installation of turnbuckle style support system*

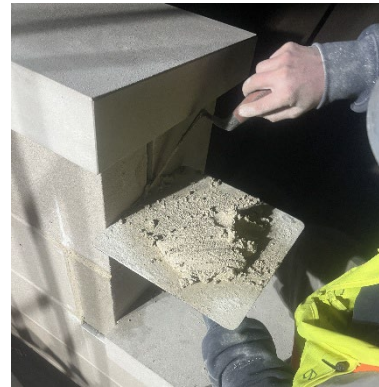
*Figure 7: Masonry Facade Restoration*

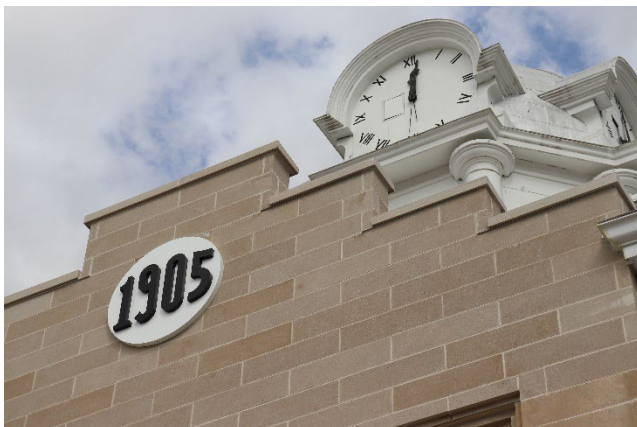
*Figure 8: Newly restored facade*

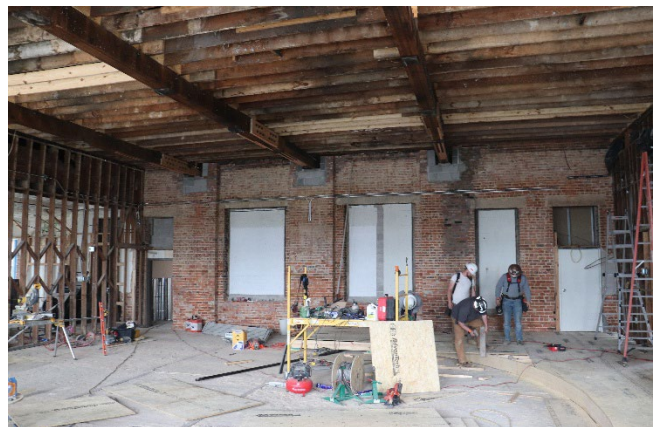
*Figure 9: Fully complete truss system*
